STAR MINE DAM

WASHINGTON COUNTY, MISSOURI

MO 31005

**PHASE 1 INSPECTION REPORT
NATIONAL DAM SAFETY INSPECTION**

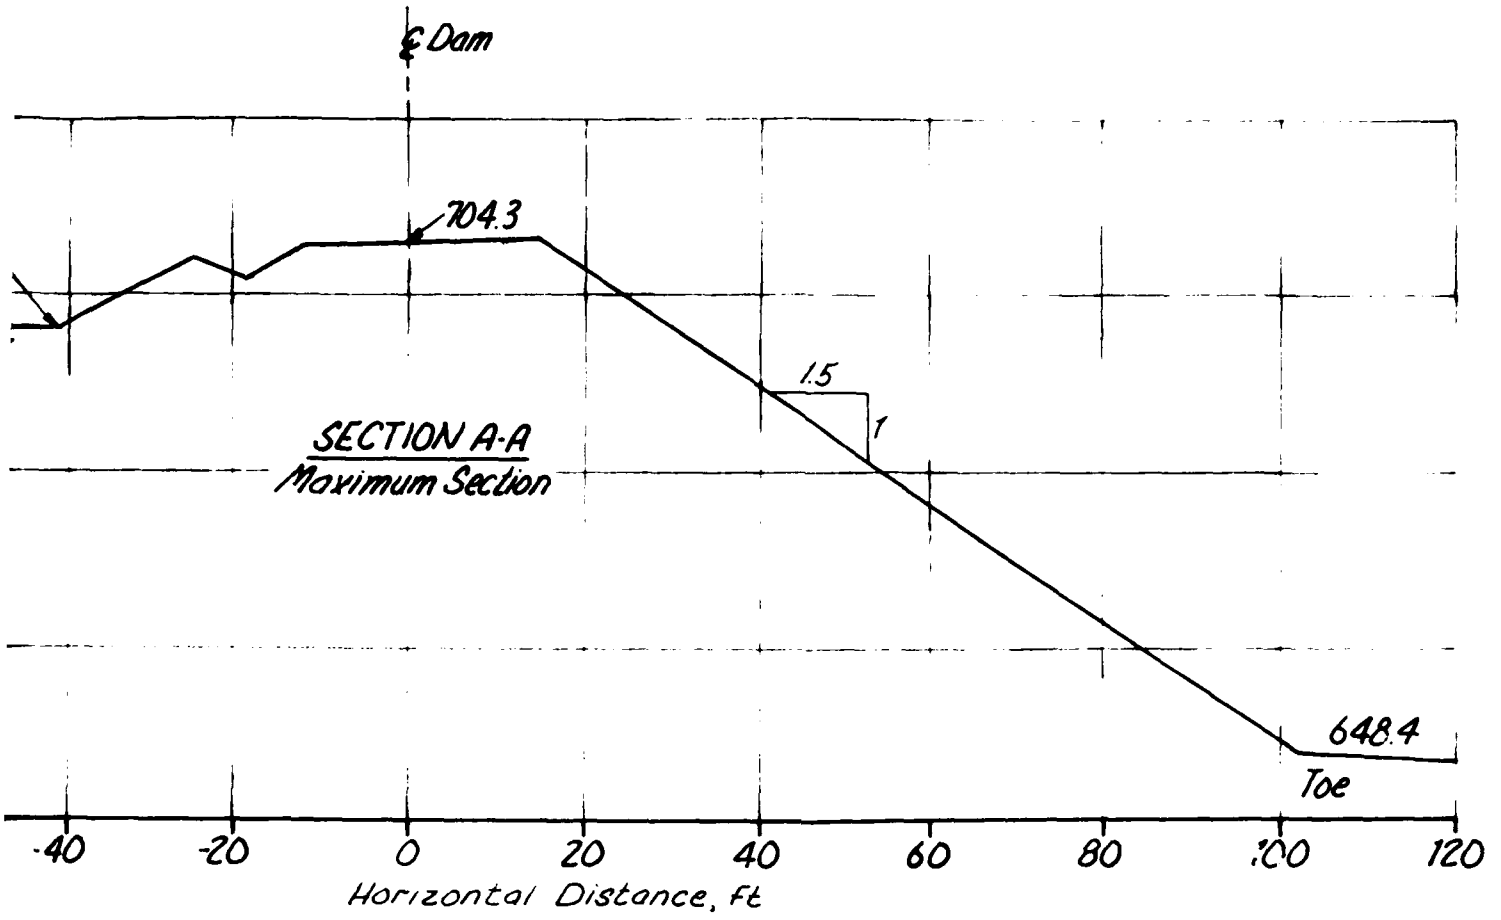
PLAN AND MAXIMUM SECTION OF DAM	
STAR MINE DAM	
MO 31005	Fig. 3-A

The Star Mine Dam is approximately 1550 ft long and is "horse-shoe" shaped in plan, with the impounded tailings to the west (see Fig 3-A). The southern portion and the eastern (central) portion of the dam are made of chat. The northern portion is constructed of gravelly residual clay (CL-CH). The dam crest varies in elevation from 704.5 to 711.1 ft (MSL). The spillway is at the far southwest corner of the dam. The discharge channel follows the toe of the dam along its southern perimeter in an easterly direction. No flow control structures exist at this facility.
